Loss Control Personnel: Darlene Wood

Date: 04-19-2021

Member Name: Madison District Public Schools

Building(s) Inspected: Administration Building

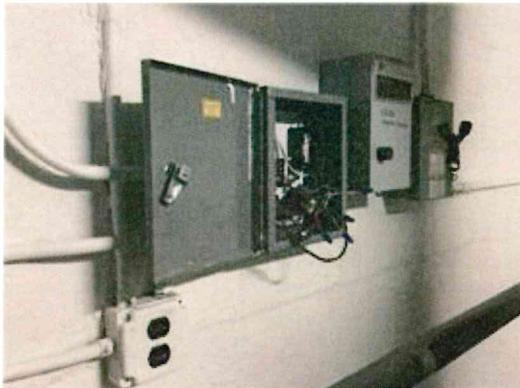
Title:	Electrical – Exposed Wiring
Recommendation:	Electrical boxes should be closed by suitable covers and securely fastened in place. Various electrical control boxes, junction boxes and electrical receptacles were observed without covers or faceplates. This is in the basement of the administrative building.
	Done

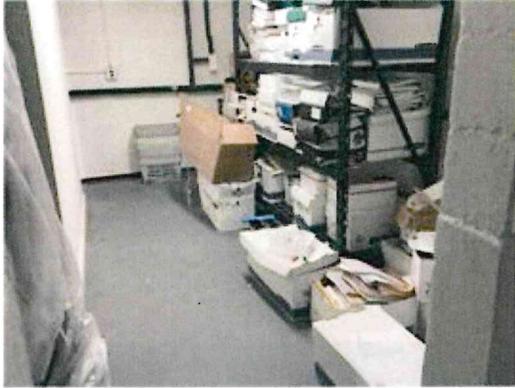
Title:	Storage on Flood
Recommendation:	There is storage on the floor in the basement. All storage should be off the floor to prevent damage in the event of water on the floor. Pricing shelving units

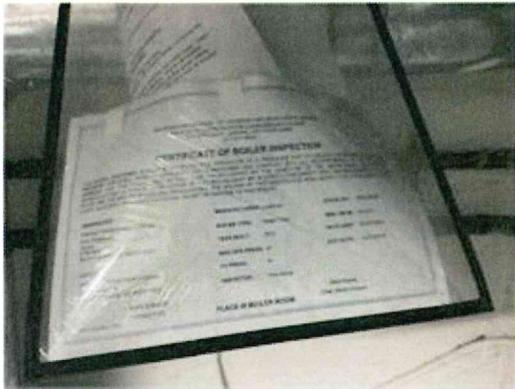
Title:	Boiler Inspection
Recommendation:	Jurisdictional inspection certificates must be obtained and posted. The boiler certificate expired in 2019. Contact a certified boiler inspection company to inspect, maintain and complete a CSD1 on your units annually. Inspection has been completed, waiting on cert.

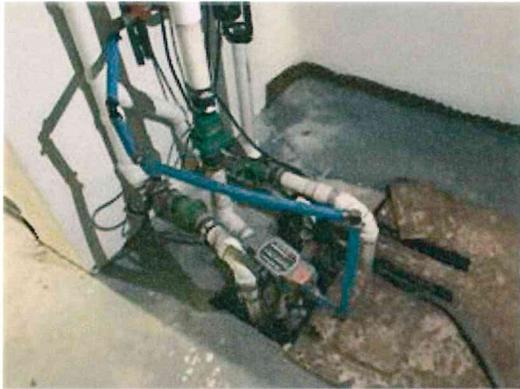
Title:	Back up Sump Pump
Recommendation:	A back up sump pump should be obtained. Preventive maintenance should be provided.

There currently is a backup pump

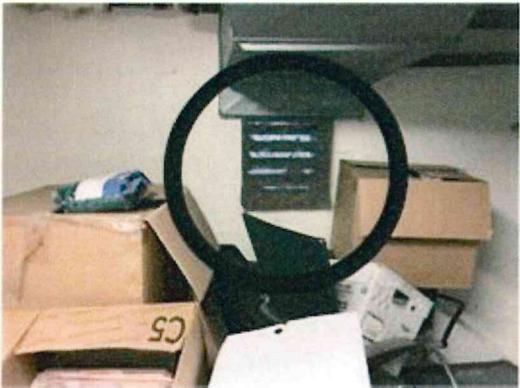
Title:	Damper in Basement Doesn't Close
Recommendation:	The damper in the basement for the boiler is open all the time. The damper should be equipped with a means to close to prevent freezing.

This being looked in to - finding a company to repair.

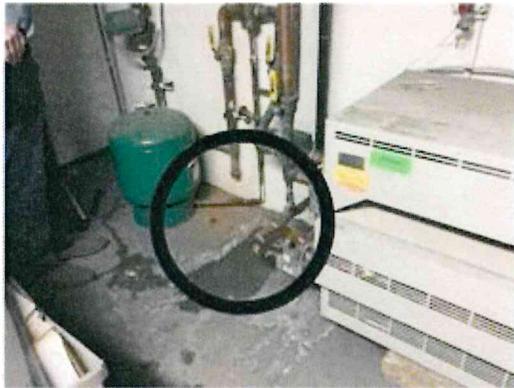
Title:	Piping Leaking
Recommendation:	The piping on this equipment is leaking. The leaks should be repaired. Detroit boiler to provide quote

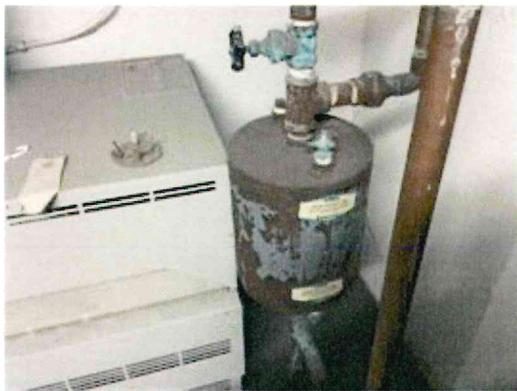
Title:	Rusted Piping
Recommendation:	The rusted piping should be replaced. Detroit boiler to quote

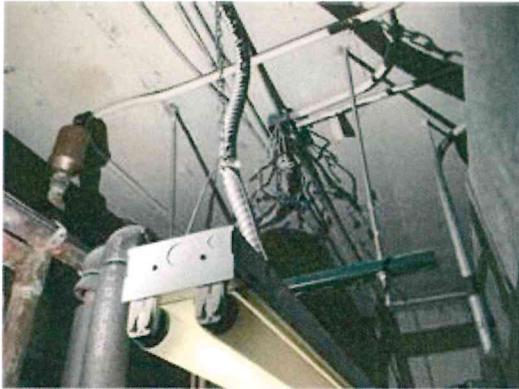
Title:	Electrical – Exposed Wiring
Recommendation:	Electrical boxes should be closed by suitable covers and securely fastened in place. Various electrical control boxes, junction boxes and electrical receptacles were observed without covers or faceplates. Will be addressed by district staff

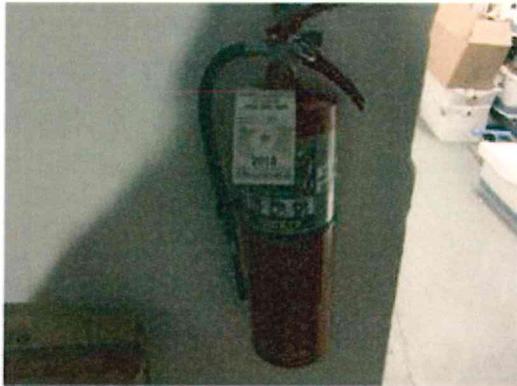
Title:	Fire Extinguishers
Recommendation:	All fire extinguishers should be serviced on an annual basis by a qualified fire extinguisher service company. A durable tag should be affixed to the fire extinguishers indicating the date of service and the identity of the company performing the service. This will help assure that the fire extinguishers will function properly in the event of a fire. The fire extinguisher in the basement was last serviced in 2018. Will be addressed this week by Conti

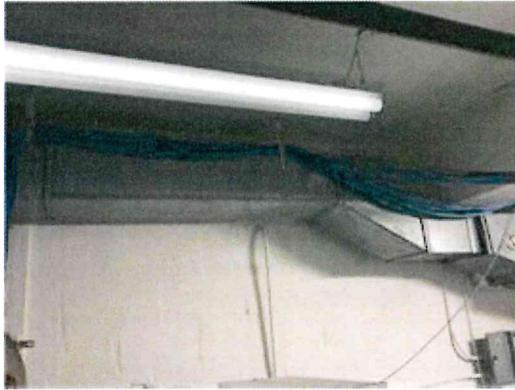
Title:	Data Feed Wire Against Metal
Recommendation:	<p>The data feed wiring is against the metal. This could potentially cause the data feed to be damaged. The metal against the data feed wiring should be removed.</p> <p style="text-align: center;">District staff will address</p>

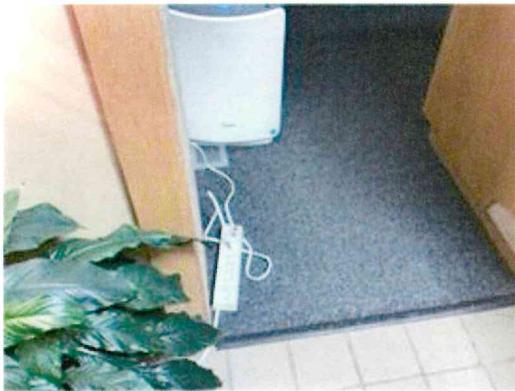
Title:	Electrical Cords & Hoses
Recommendation:	<p>Use an UL Approved electrical cord cover over the outstretched cord to help minimize slips/trips/falls. Eliminate the overuse of electrical cords, power strips and extension cords, to help minimize electrical hazards and slips/trips/falls. Develop procedures for proper electrical cord storage to help minimize slips/trips/falls.</p> <p style="text-align: center;">Done</p>

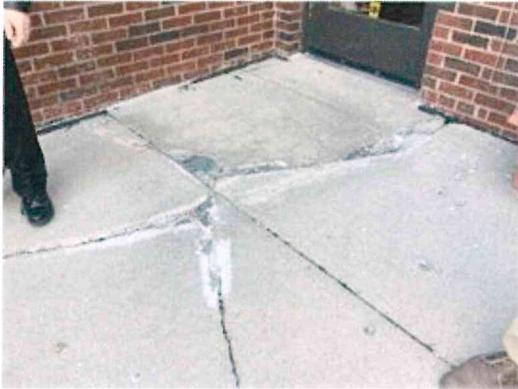
Title:	Slip, Trip, and Fall Hazard
Recommendation:	Eliminate slip, trip, and fall exposure by repairing the sidewalks. District staff will skimcoat.

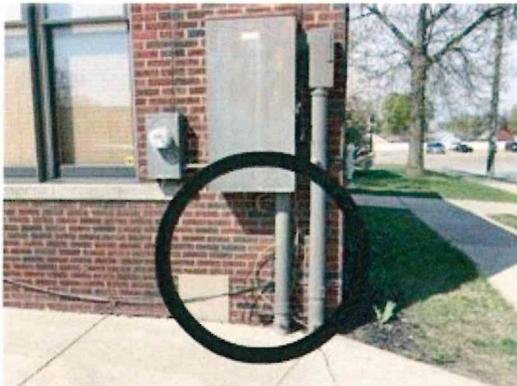
Title:	Electrical – Exposed Wiring
Recommendation:	Electrical boxes should be closed by suitable covers and securely fastened in place. Various electrical control boxes, junction boxes and electrical receptacles were observed without covers or faceplates. Old cable wires will be removed and secured

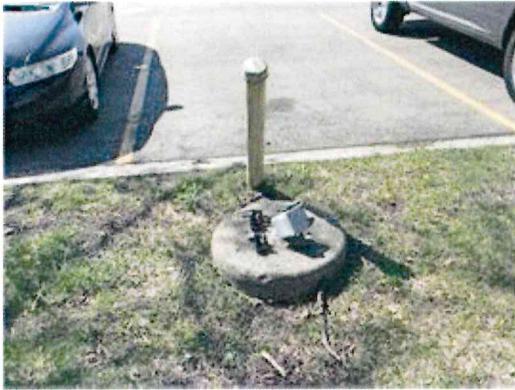
Title:	Light Pole Damaged
Recommendation:	<p>The light pole has been removed. Additional fixtures on the cement should be removed.</p> <p style="text-align: center;">Will be addressed by district staff.</p>

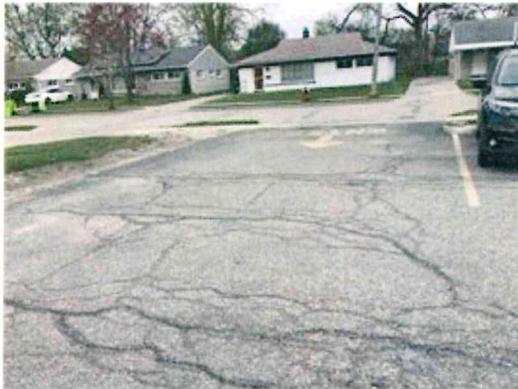
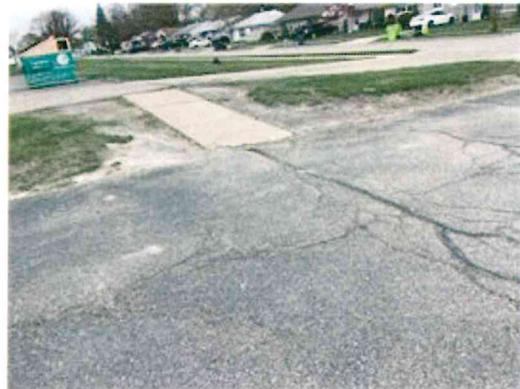
Title:	Slip, Trip, and Fall Hazard
Recommendation:	Eliminate slip, trip, and fall exposure by repairing parking lot and sidewalks. This has not yet been addressed. Hoping to address with bond funding

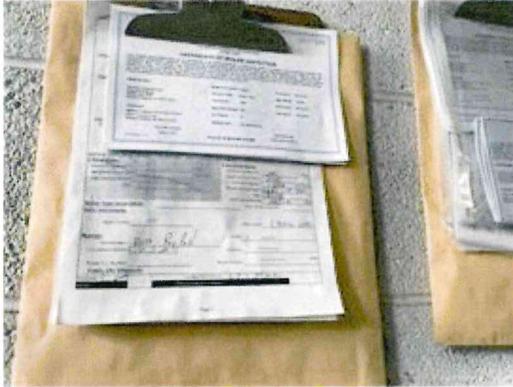
Title:	Boiler Inspection
Recommendation:	<p>Jurisdictional inspection certificates must be obtained and posted. The boiler certificate does not expire until 10-2021. Contact a certified boiler inspection company to inspect, maintain and complete a CSD1 on your units annually. There was no current CSD1. This is an outstanding recommendation from the 2-9-2016 and 1-24-2017 report.</p> <p style="text-align: center;">Completed 6-23-21</p>

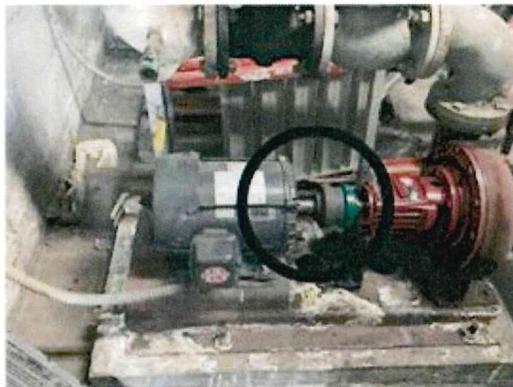
Title:	Pumps Not Guarded
Recommendation:	<p>The two pumps in the boiler room are not adequately guarded. In addition, the one pump running was loud indicating that the bearings might need repair.</p> <p style="text-align: center;">Working with Detroit Boiler to address this.</p>

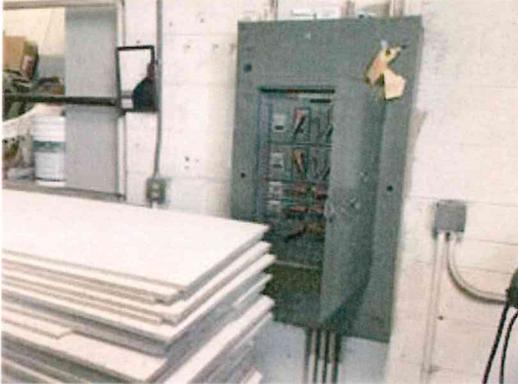
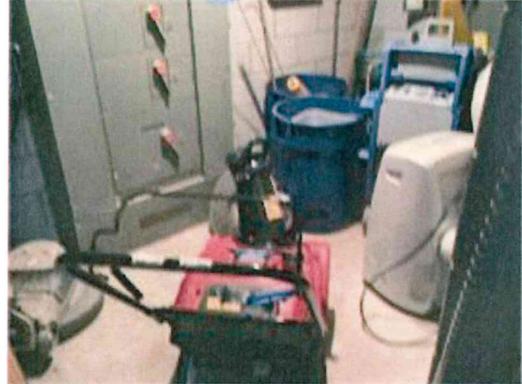
Title:	Electrical Panels Blocked
Recommendation:	Remove the items and materials being stored in front of the electrical panels per NFPA Life Safety Codes. There should be a minimum of 3-feet of clearance in front of and around the panels. Yellow caution lines could be painted to designate the area around the electrical panels where storage is not permitted.
	Done

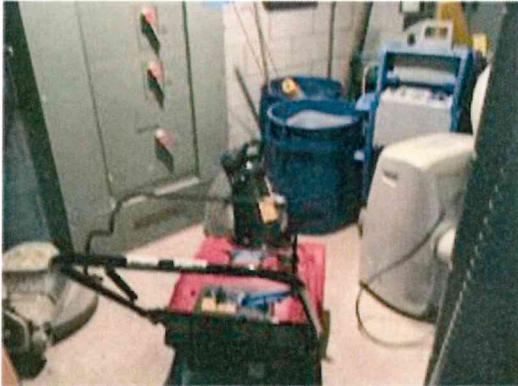
Title:	Snow Blower Stored Inside
Recommendation:	The snow blower is being stored inside. The snow blower should be stored outside.
	Done

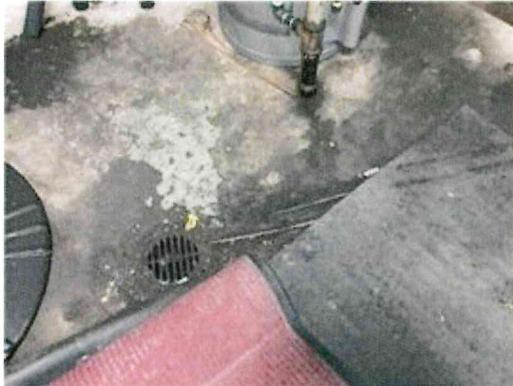
Title:	Water/Oil Leakage
Recommendation:	<p>The water/oil leakage in the boiler room should be repaired.</p> <p style="text-align: center;">Done by contractor 6-23-21</p>

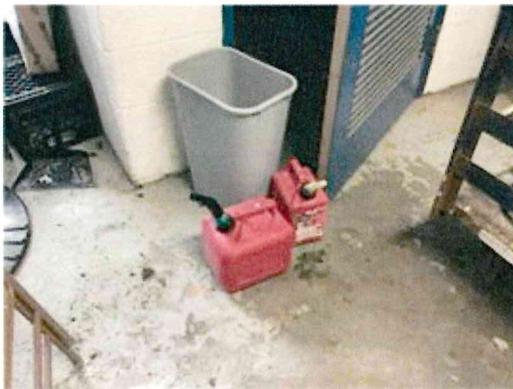
Title:	Flammable Liquid Storage
Recommendation:	<p>Store all flammables such as paints, thinners, adhesives and aerosols inside a UL approved cabinet for storage of the flammables. These cabinets are specially designed to isolate the flammable liquids from a fire, reducing the potential for their contributing to the rapid spread of a fire.</p> <p style="text-align: center;">Pricing flammable storage cabinets</p>

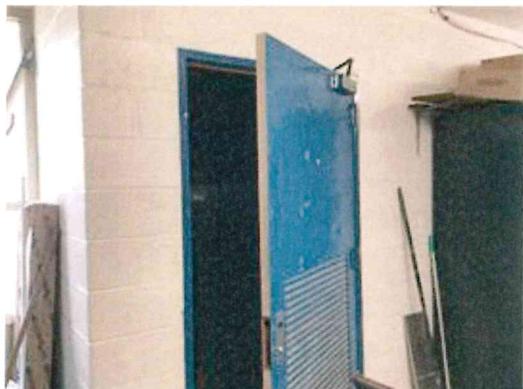
Title:	Electrical Door
Recommendation:	The electrical door does not close. This door should be kept closed at all times. Storage should be removed from room.

Not yet addressed, putting together a parts list

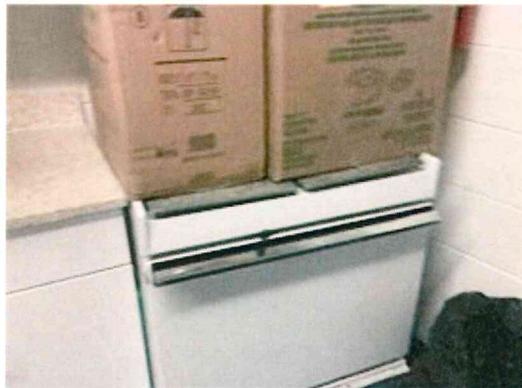
Title:	Remove Combustibles from Stove
Recommendation:	There are combustibles on the stove in the kitchen. These items should be removed.

Done

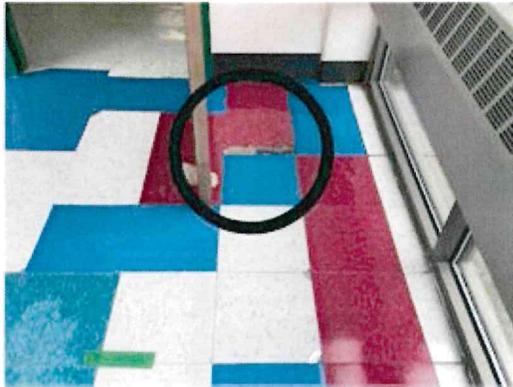
Title:	Slip, Trip, and Fall Hazard
Recommendation:	Eliminate slip, trip, and fall exposure by repairing the floor tiles. This is an outstanding recommendation from the 1-24-2017 report. Done

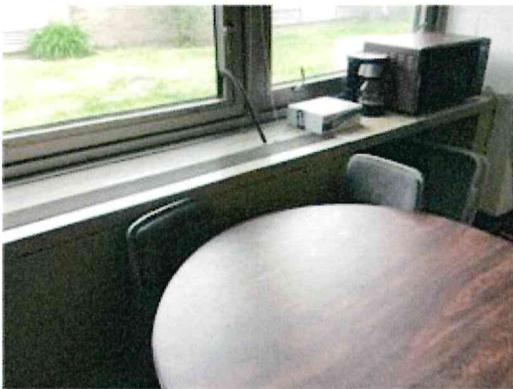
Title:	Univent Heater - Remove Items
Recommendation:	Remove items that are placed on top of, or in front of, the univent heaters. Items should be removed to ensure the heaters function correctly. Excessive items placed on top of, or in front of, the univent may cause it to fail and lead to potential damage. Implement preventative maintenance for univents. In addition, the window insulation is coming out and should be repaired. Done

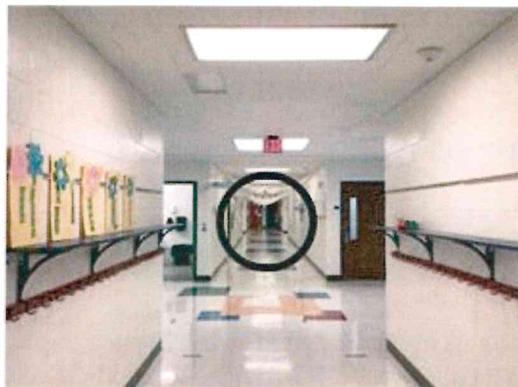
Title:	Exit Signs
Recommendation:	<p>The exit signs are blocked by the ceiling decorations. The ceiling decorations should be removed to facilitate egress in the event of an emergency. Currently the exit sign can not be seen with the ceiling decorations.</p> <p style="text-align: center;">Done</p>

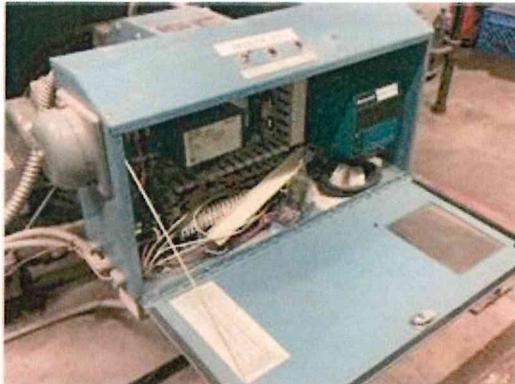
Title:	Boiler Inspection
Recommendation:	Jurisdictional inspection certificates must be obtained and posted. The certificate expired 2019. This is an outstanding recommendation from the 2-10-2016 report. Contact a certified boiler inspection company to inspect, maintain and complete a CSD1 on your units annually. There was no CSD1. The boiler controls were left open. The boiler controls should be kept closed. Done - Completed by a contractor

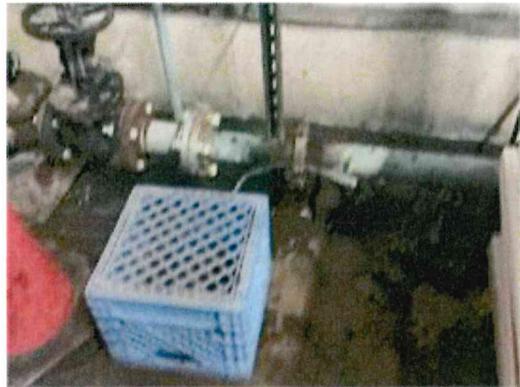
Title:	Automatic Sprinkler Piping Leakage
Recommendation:	There is a leak in the automatic sprinkler piping that should be repaired. There is an significant amount of water on the floor from the sprinkler piping. This is being inspected this week by Conti

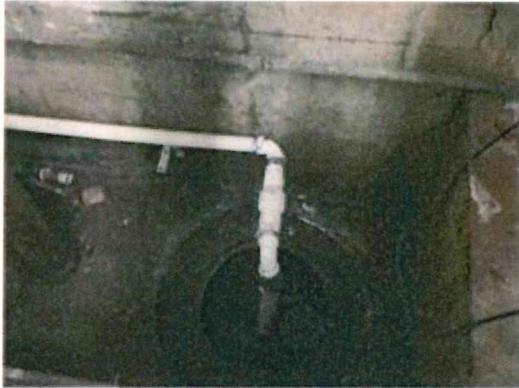
Title:	Sump Pump - No Back Up
Recommendation:	There is no emergency back up on the sump pump in the boiler room. We have purchased a pump - needs to be installed.

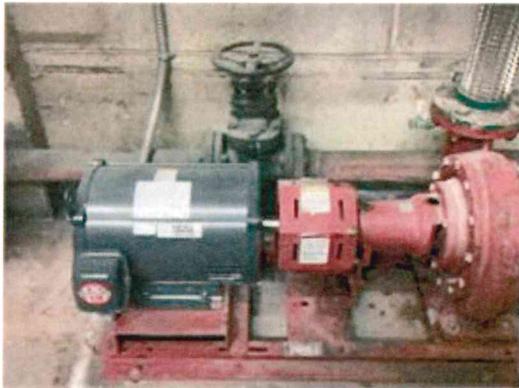
Title:	Motor on Pump Running Loud
Recommendation:	The motor on the pump is running loud indicating that the bearing should be repaired. Bearings were greased on 6/18/21

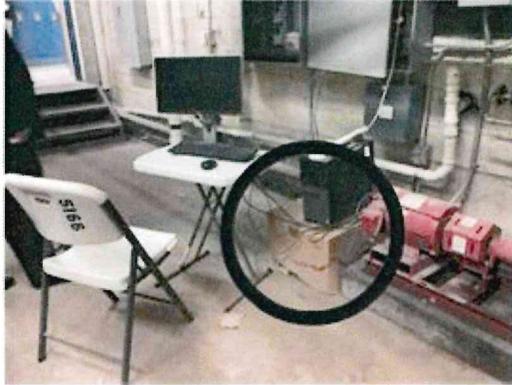
Title:	Computer Equipment in Boiler Room
Recommendation:	<p>There was computer equipment in the boiler room on a cardboard box. The computer equipment should be secure and on a table.</p> <p style="text-align: center;">Done</p>

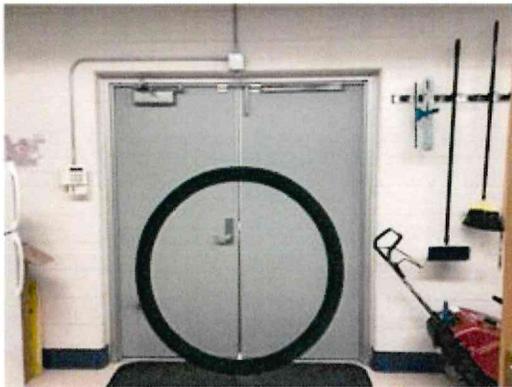
Title:	Door Not Sealed
Recommendation:	<p>The door in the receiving room is not sealed and is letting a significant amount of air (possibly cold) into the room. The main for the automatic sprinkler system is located in this room.</p> <p style="text-align: center;">Done</p>

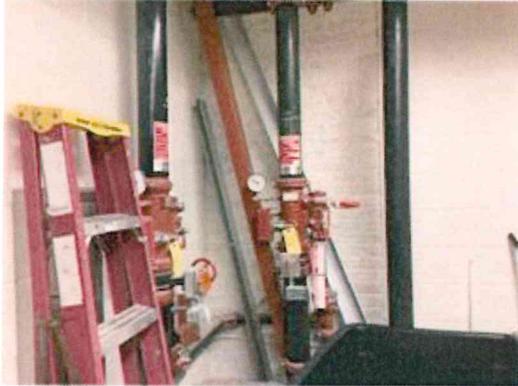
Title:	Blocked Automatic Sprinkler System
Recommendation:	There is storage in front of the automatic sprinkler system. The storage should be removed. The automatic sprinkler system should be kept clear at all times. As a reminder, lines should be painted on the floor to mark the area where storage should not be.

Done

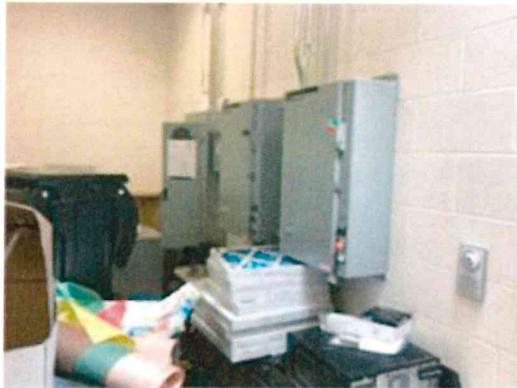
Title:	Electrical Panels Blocked
Recommendation:	Remove the items and materials being stored in front of the electrical panels per NFPA Life Safety Codes. There should be a minimum of 3-feet of clearance in front of and around the panels. Yellow caution lines could be painted to designate the area around the electrical panels where storage is not permitted.

Done

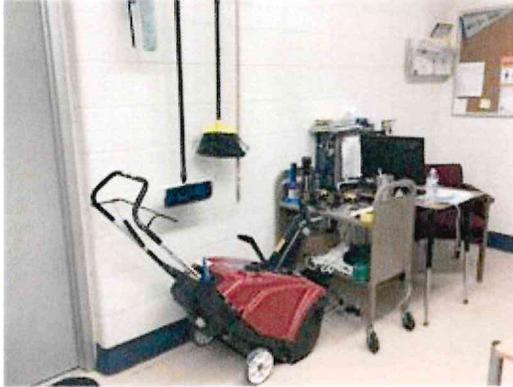
Title:	Snow Blower Inside
Recommendation:	The snow blower is located in the receiving room. The snow blower should be stored outside. Done

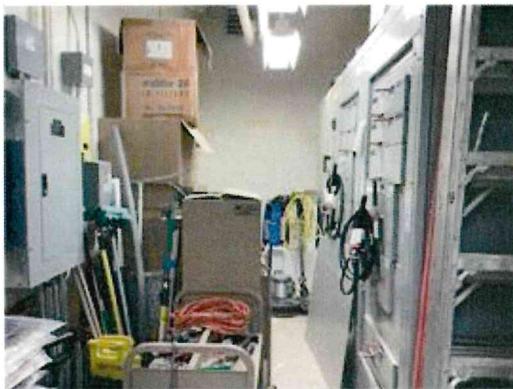
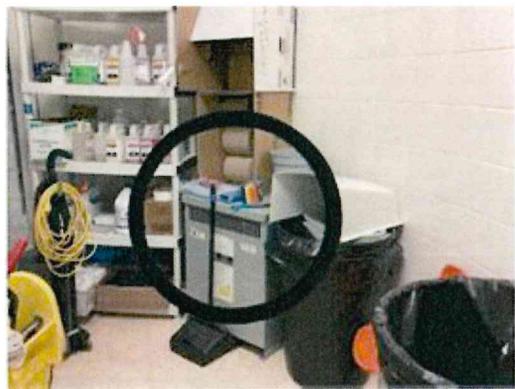
Title:	Electrical Panels Blocked
Recommendation:	Remove the items and materials being stored in front of the electrical panels per NFPA Life Safety Codes. There should be a minimum of 3-feet of clearance in front of and around the panels. Yellow caution lines could be painted to designate the area around the electrical panels where storage is not permitted. In addition, the storage on the transformer should be removed. (Storage was removed during the visit.) Done

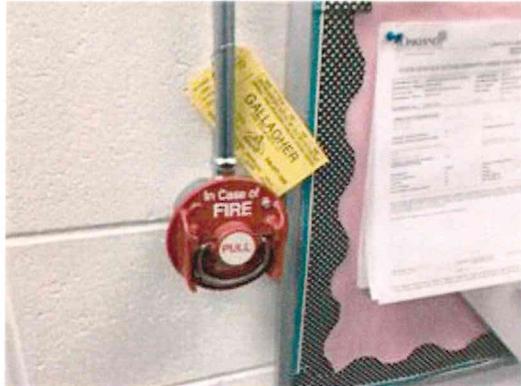
Title:	Kitchen Extinguishing System
Recommendation:	<p>The automatic extinguishing system protecting the cooking surfaces and exhaust duct should be serviced and tagged on a semi-annual basis by a qualified outside contractor to ensure reliable operation. The last test was completed July 2020.</p> <p style="text-align: center;">This will be completed this week by Conti</p>

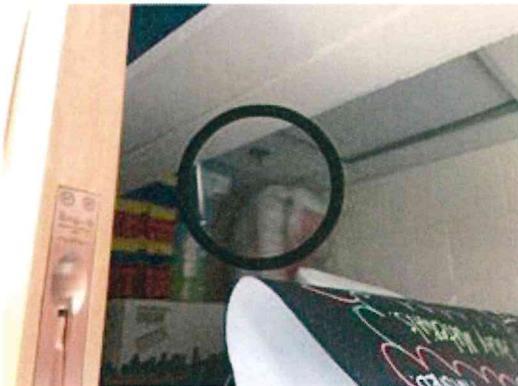
Title:	Automatic Sprinkler Head Clearance
Recommendation:	<p>Storage should be a minimum of 18 inches from any automatic sprinkler head. Limit storage on top shelves to reduce slip and fall exposures. Blocking these automatic sprinkler heads could result in decreased flow of water in case of a fire. The storage room in the art room is packed with storage and could overburden the automatic sprinkler head in the storage room.</p> <p style="text-align: center;">This was brought to the teachers attention and will be addressed.</p>

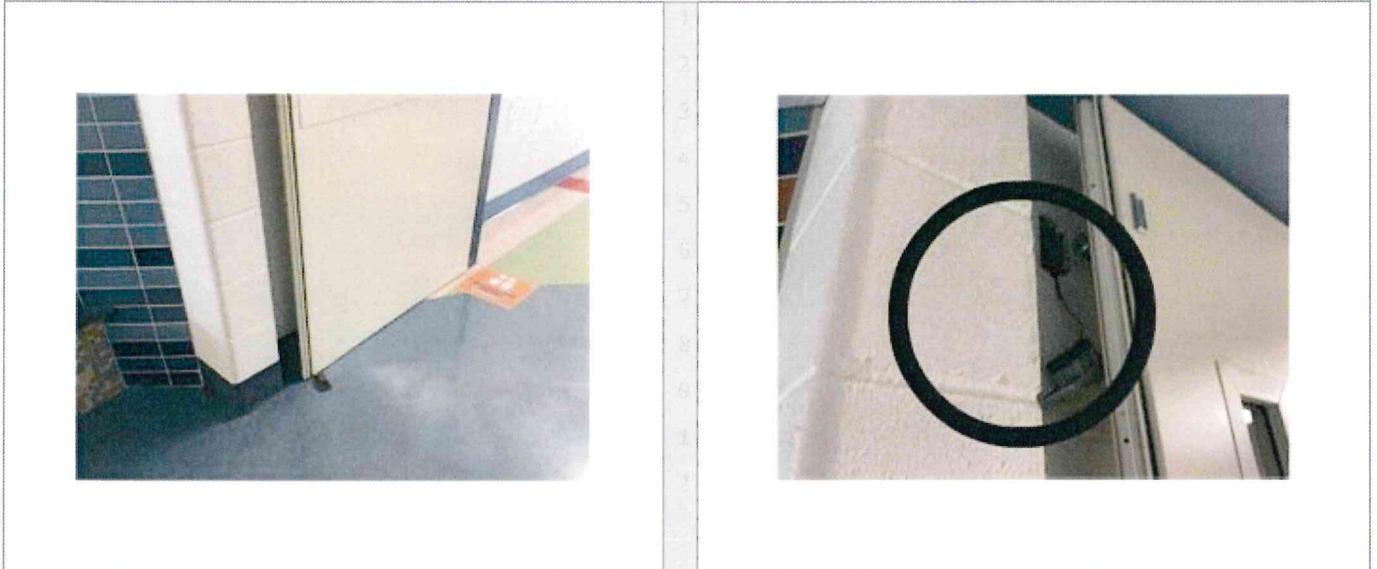
Title:	Fire Doors Blocked Open
Recommendation:	<p>The fire doors are blocked open because the automatic fire system closure is damaged. The fire system closure should be repaired and the doors should not be blocked open.</p> <p style="text-align: center;">There is an appointment scheduled with WonDoor to have this fixed.</p>

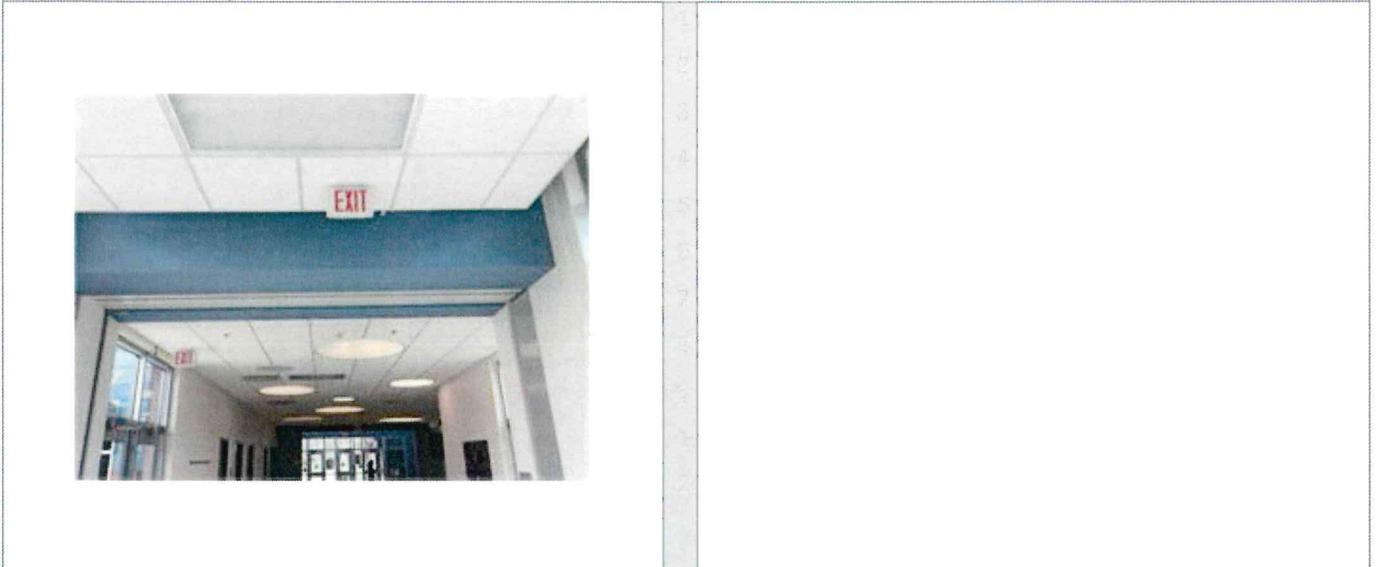
Title:	Exit Signs
Recommendation:	<p>Replace burned-out exit signs to ensure adequate egress.</p> <p style="text-align: center;">Done</p>

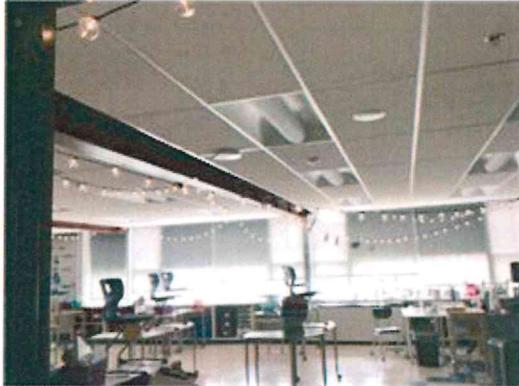
Title:	String-to-String Lights
Recommendation:	<p>Remove string-to-string lights that are coming into contact with lighting fixtures, combustible materials, and furniture. This can expose the district to fires, burns, or various injuries.</p> <p style="text-align: center;">This was brought to the teacher's attention</p>

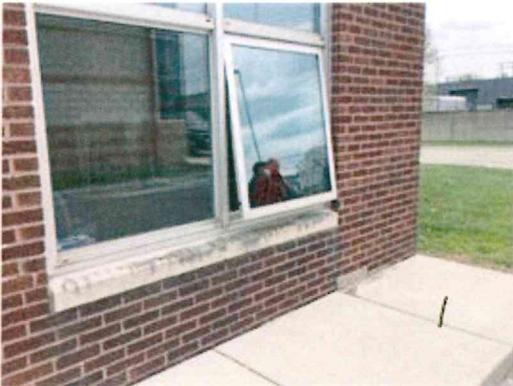
Title:	Breach in Security
Recommendation:	<p>Keep all exit doors securely closed and locked to help minimize a breach in security.</p> <p style="text-align: center;">This was brought to teacher's attention</p>

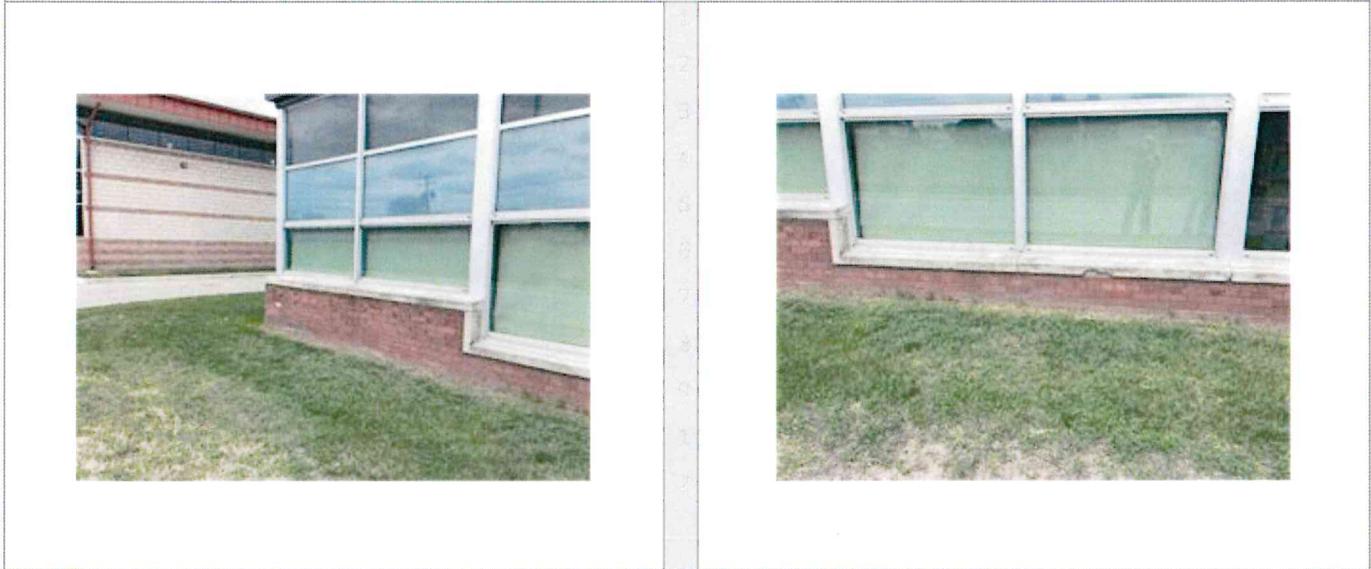
Title:	Cement Sill Damaged
Recommendation:	The cement window sill is damaged and should be repaired. Done

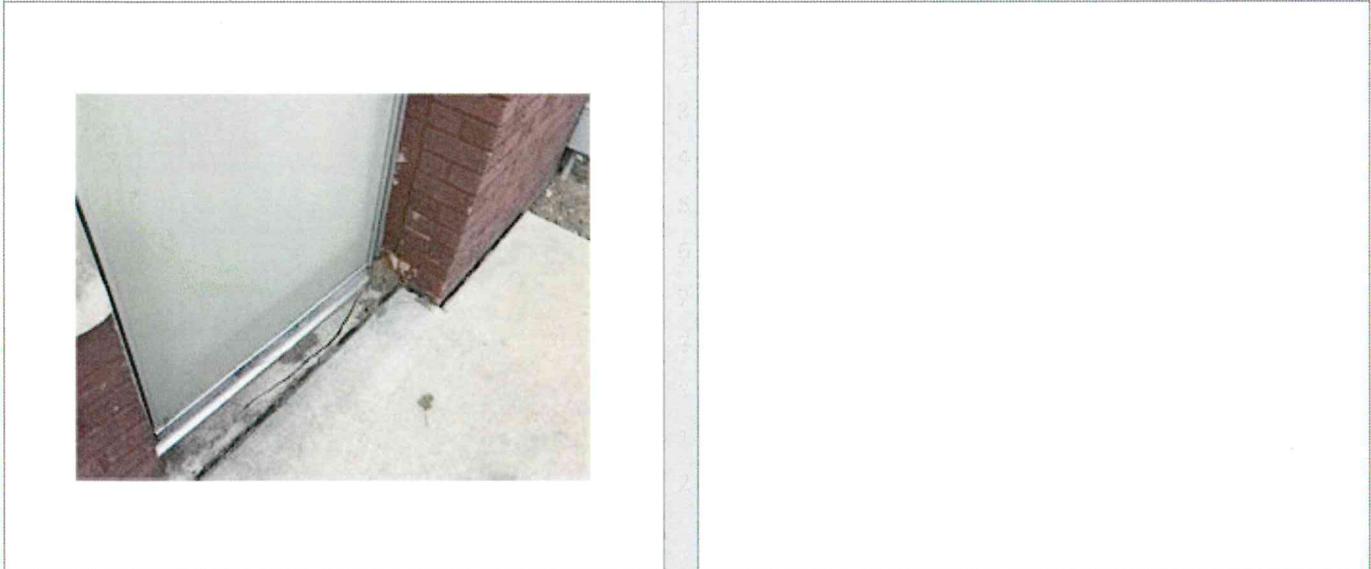
Title:	Door Sill Damaged
Recommendation:	The door sill is damaged and should be repaired. Done

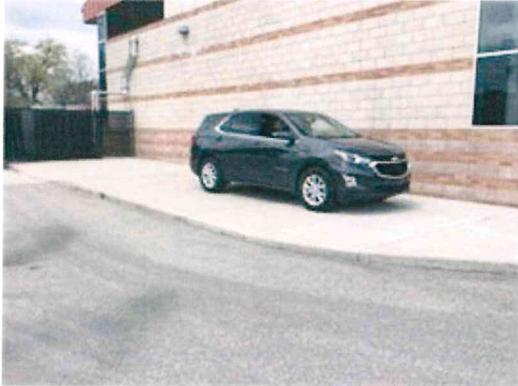
Title:	Car on Sidewalk
Recommendation:	<p>Cars should not be parked on the sidewalk as sidewalks can't hold the weight of the car. The car could damage the sidewalk. Cars should be parked in the designated parking spaces.</p> <p style="text-align: center;">Addressed with staff.</p>

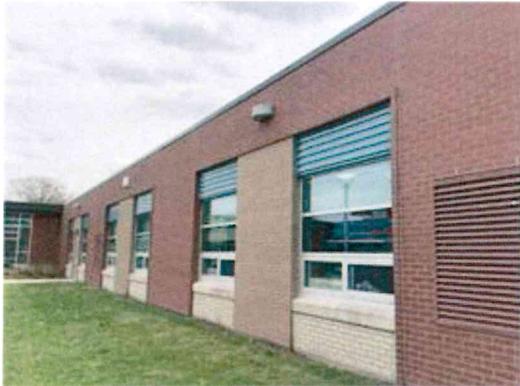
Title:	Lack of Cameras on Rear of Building
Recommendation:	<p>There are no cameras on the rear of building. Consideration should be given to adding cameras to the rear of the building.</p> <p style="text-align: center;">A camera is being added in this location</p>

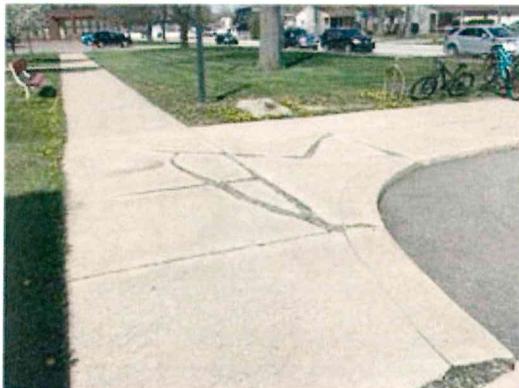
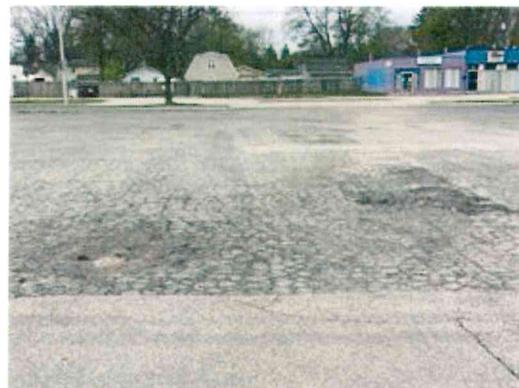
Title:	Slip, Trip, and Fall Hazard
Recommendation:	Eliminate slip, trip, and fall exposure by repairing sidewalks and parking lots. This is an outstanding recommendation from the 9-27-2018 report. Hoping to use bond funding to fix

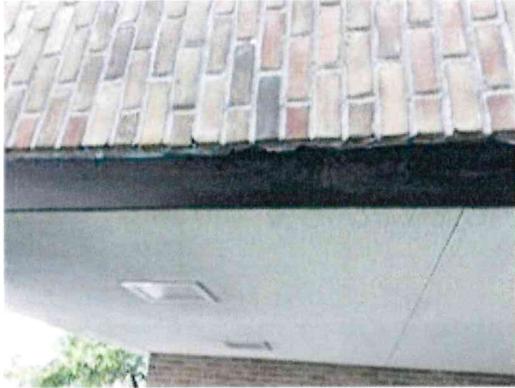
Title:	Awning Repair
Recommendation:	The brick around the building is separating and should be repaired. In addition, the metal is deteriorating and should be repaired. Exploring options to repair

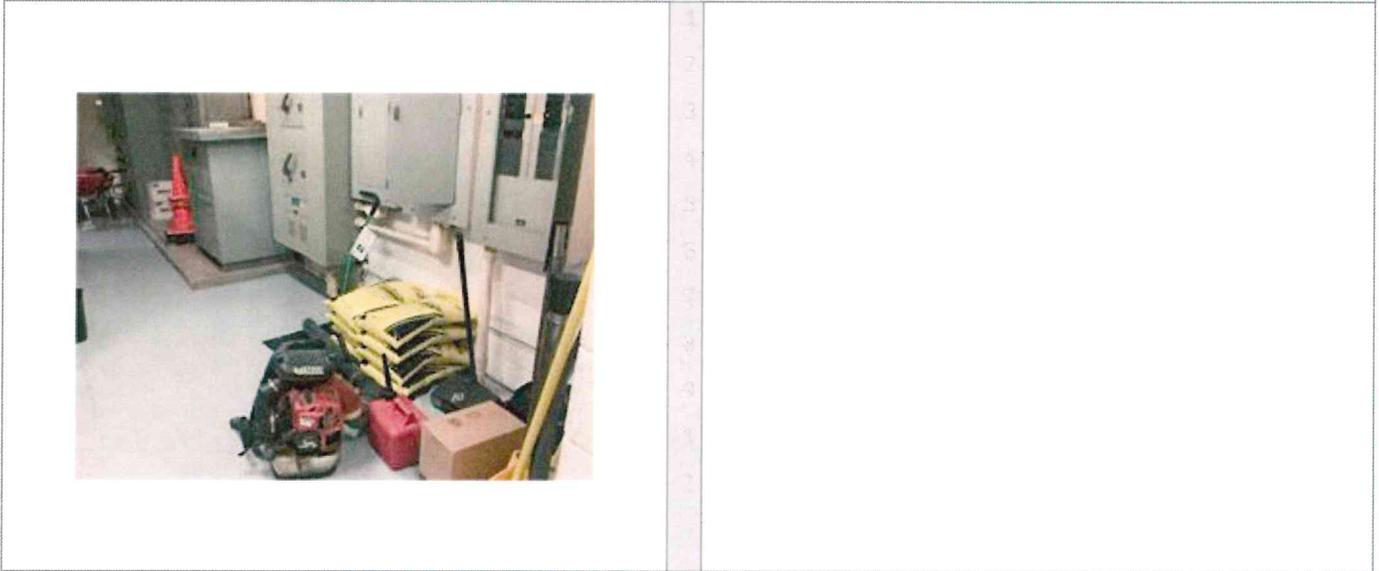
Title:	Electrical Panels Blocked
Recommendation:	Remove the items and materials being stored in front of the electrical panels per NFPA Life Safety Codes. There should be a minimum of 3-feet of clearance in front of and around the panels. Yellow caution lines could be painted to designate the area around the electrical panels where storage is not permitted. This is an outstanding recommendation from the 9-27-2018 report. Done

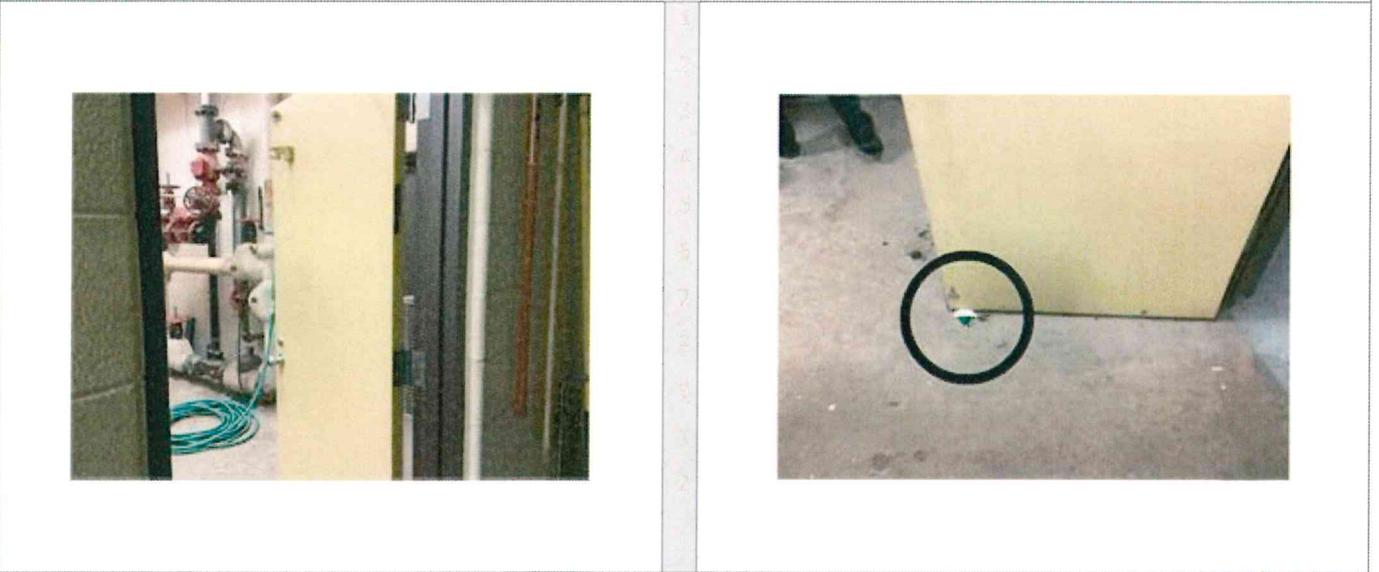
Title:	Boiler Room Door Blocked Open
Recommendation:	The boiler room door is blocked open. The door should be kept closed at all times. Done

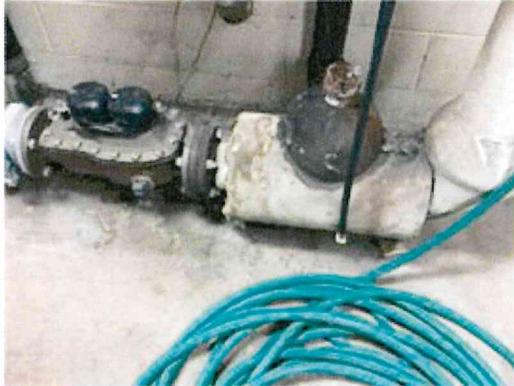
Title:	Asbestos Covering Damaged
Recommendation:	The asbestos covering in the boiler room are damaged. They should be repaired. Appointment scheduled with NOVA Environmental

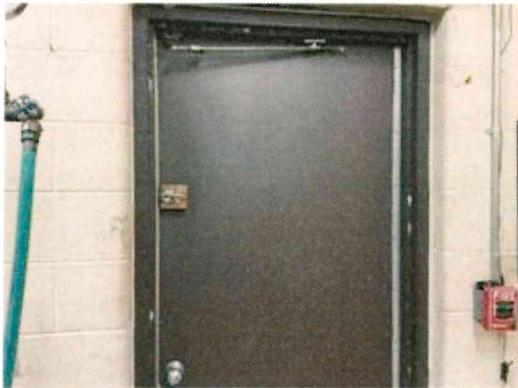
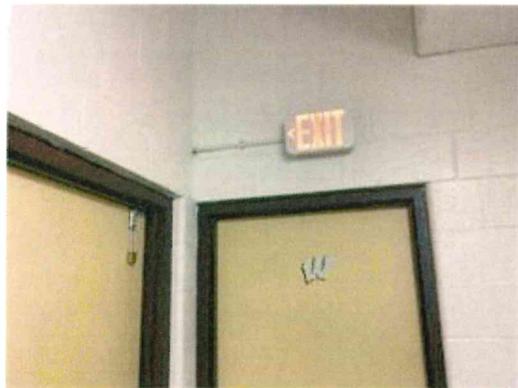
Title:	Doors With Pad Locks
Recommendation:	Doors in the boiler room and locker rooms are pad locked. Pad locks impede egress in the event of an emergency and should be removed. Done

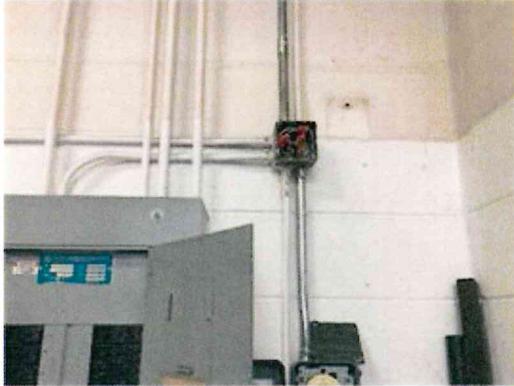
Title:	Electrical – Exposed Wiring
Recommendation:	Electrical boxes should be closed by suitable covers and securely fastened in place. Various electrical control boxes, junction boxes and electrical receptacles were observed without covers or faceplates. This is an outstanding recommendation from the 9-27-2018 report.
	Done

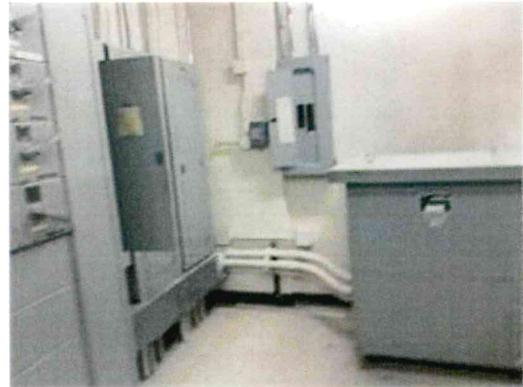
Title:	Electrical – Exposed Wiring
Recommendation:	Electrical boxes should be closed by suitable covers and securely fastened in place. Various electrical control boxes, junction boxes and electrical receptacles were observed without covers or faceplates. This is an outstanding recommendation from the 9-27-2018 report.
	Done

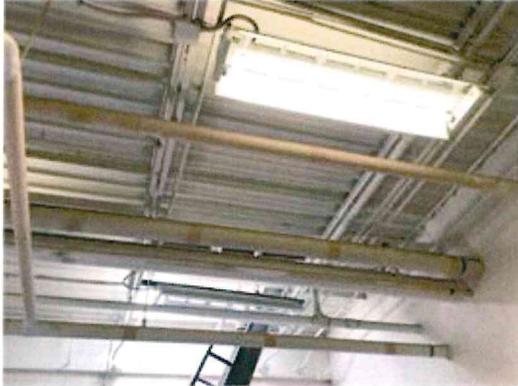
Title:	Light Fixtures Missing Bulbs
Recommendation:	The light fixtures in the receiving area are missing bulbs. Proper lighting is needed to ensure egress and working in the area with slip and falling.
	Done

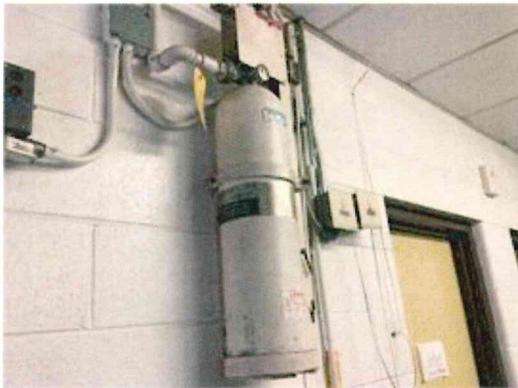
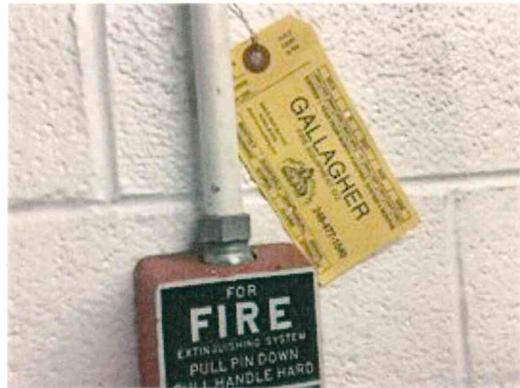
Title:	Kitchen Extinguishing System
Recommendation:	The automatic extinguishing system protecting the cooking surfaces and exhaust duct should be serviced and tagged on a semi-annual basis by a qualified outside contractor to ensure reliable operation. The last inspection was July 2020. This is an outstanding recommendation from the 9-27-2018 report.
	This will be done this week by Conti

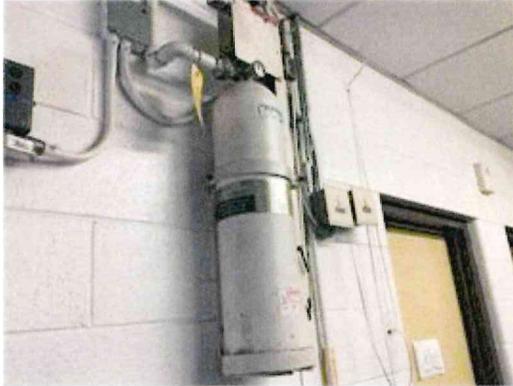
Title:	Kitchen Extinguishing System - Hydrostatic Testing
Recommendation:	<p>The kitchen extinguishing system should be hydro tested according to NFPA once every 7 years. This system has never had a hydro test.</p> <p style="text-align: center;">This will be done this week by Conti</p>

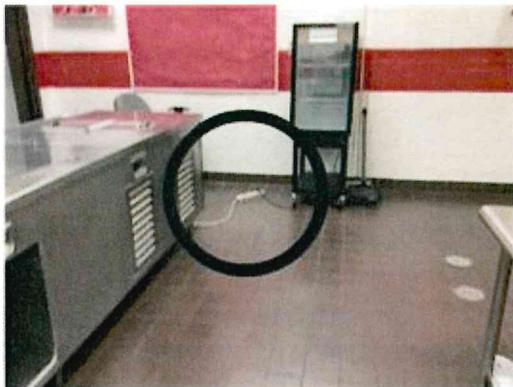
Title:	Slip, Trip, and Fall Hazard
Recommendation:	<p>Eliminate slip, trip, and fall exposure by eliminating extension cords on the floor. This was noted in the kitchen serving area.</p> <p style="text-align: center;">Done</p>

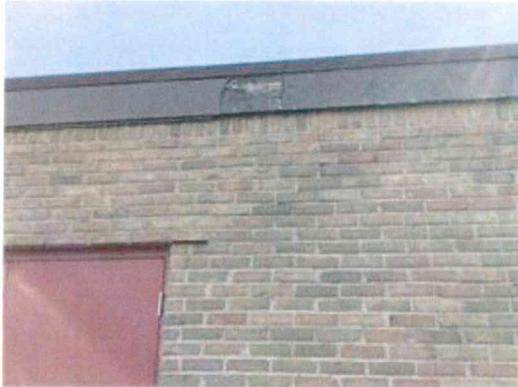
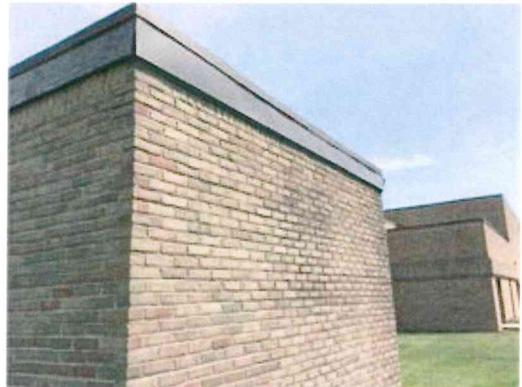
Title:	Fascia Boards on Shed Damaged
Recommendation:	The fascia boards on the shed are damaged and could cause water to enter the building. The fascia boards should be repaired.

Will be completed by school staff

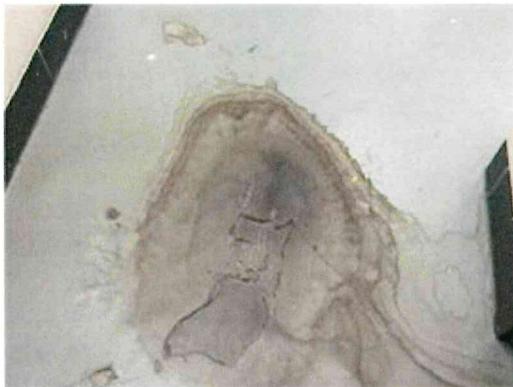
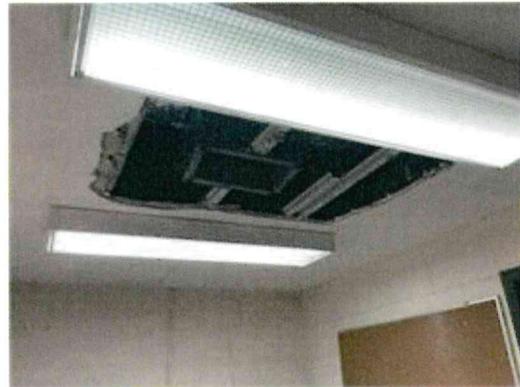
Title:	Roof Leak Damage
Recommendation:	Roof leaking has caused damaged to the floors in the locker rooms and ceiling tiles missing. Exposed ceiling tiles should be replaced. Can be fixed once roof is repaired

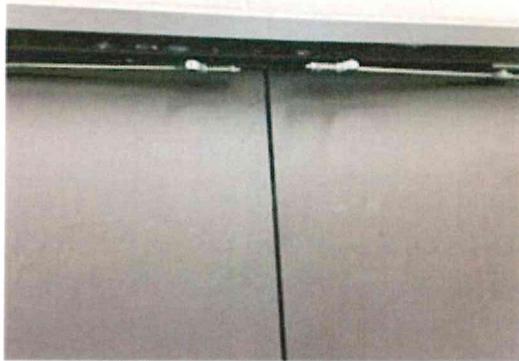
Title:	Rear Doors no Security
Recommendation:	<p>The rear doors at the middle school do not have burglary contacts on them. The rear side of the building does not have camera coverage. To increase security, burglary contacts and cameras should be provided.</p> <p style="text-align: center;">Need to speak with Tyco</p>

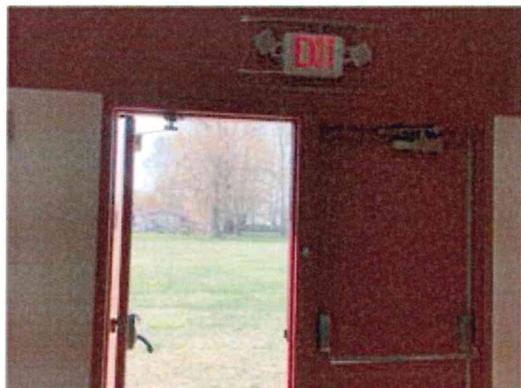
Title:	Breach in Security
Recommendation:	Keep all exit doors securely closed and locked to help minimize a breach in security.
	Done

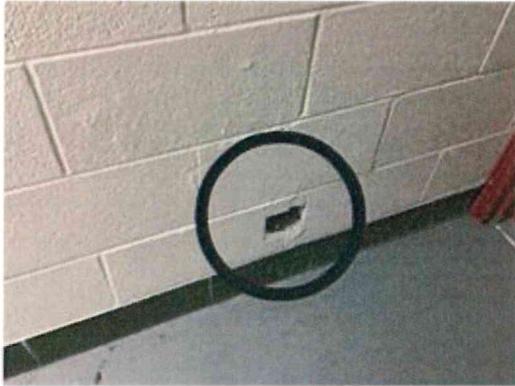
Title:	Electrical – Exposed Wiring
Recommendation:	Electrical boxes should be closed by suitable covers and securely fastened in place. Various electrical control boxes, junction boxes and electrical receptacles were observed without covers or faceplates.

In progress

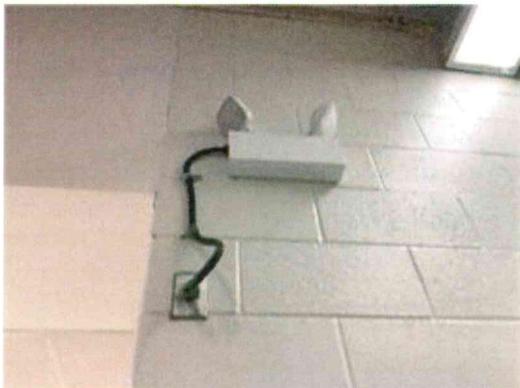
Title:	Emergency Lighting and Exit Signs
Recommendation:	A preventive maintenance program should be instituted to include testing of emergency equipment- lights and exit signs. Fire strobe lights should also be included.

Done
