Loss Control Personnel: Darlene Wood

Date: 04-19-2021

Member Name: Madison District Public Schools

Building(s) Inspected: Administration Building

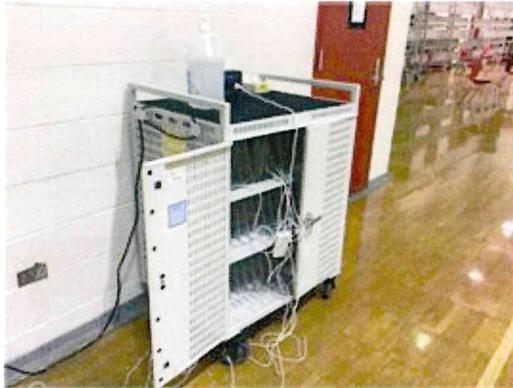
Title:	Secure Computers
Recommendation:	The computers in carts should be secure. Done

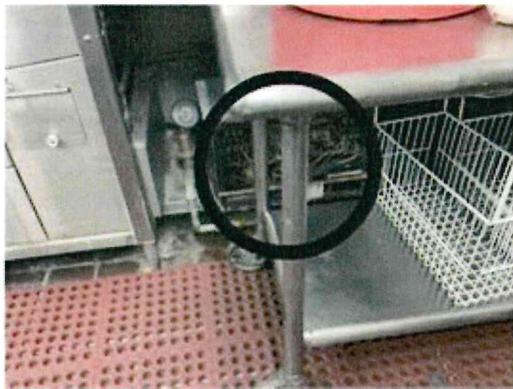
Title:	Cover Missing on Dishwasher
Recommendation:	The cover is missing on the dishwasher. This should be replaced. Done

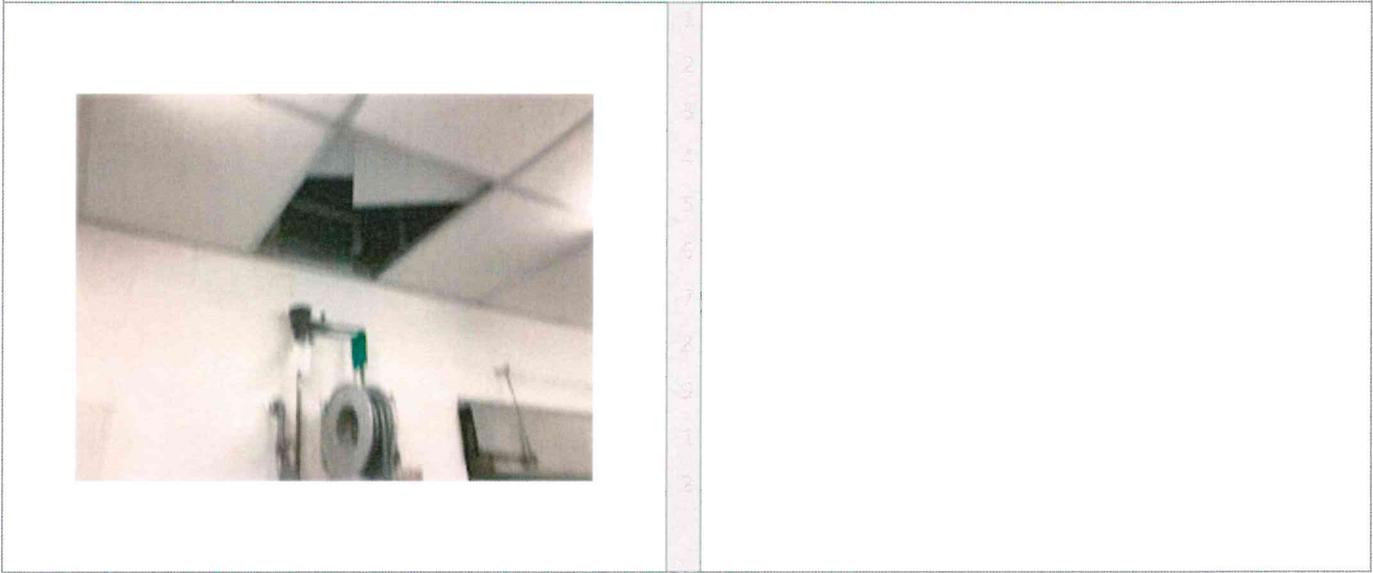
Title:	Ceiling Tiles Removed
Recommendation:	The ceiling tiles should be replaced in the dishwashing area. Done

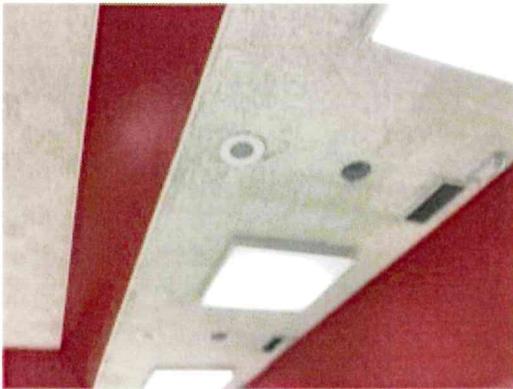
Title:	Asbestos Tiles
Recommendation:	The ceiling tiles in the cafeteria are asbestos. These should be listed on the asbestos plan.
	Listed on plan

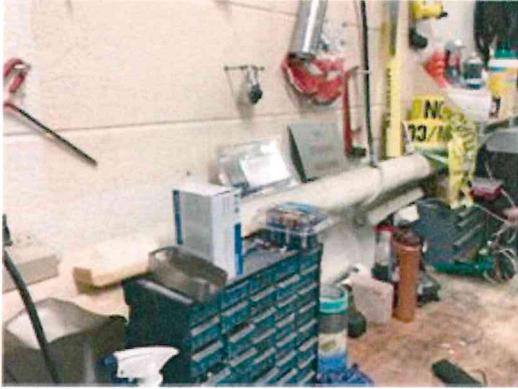
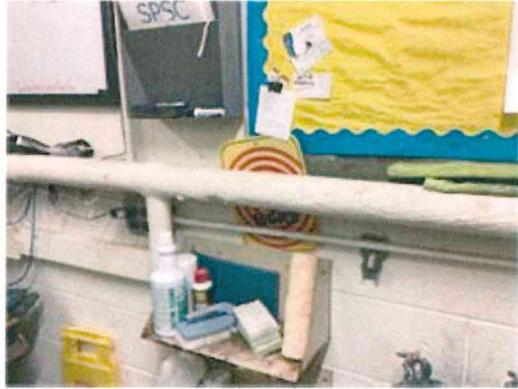
Title:	Storage in the Maintenance Area on the Asbestos Covered Piping
Recommendation:	<p>The storage on the asbestos piping in the maintenance area should be removed. The pipe covering should be listed in the asbestos plan.</p> <p style="text-align: center;">Done - pipe listed.</p>

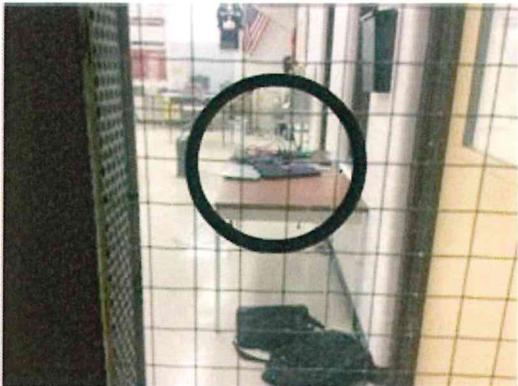
Title:	Electrical Cords & Hoses
Recommendation:	<p>Use an UL Approved electrical cord cover over the outstretched cord to help minimize slips/trips/falls. Eliminate the overuse of electrical cords, power strips and extension cords, to help minimize electrical hazards and slips/trips/falls. Develop procedures for proper electrical cord storage to help minimize slips/trips/falls.</p> <p style="text-align: center;">Done</p>

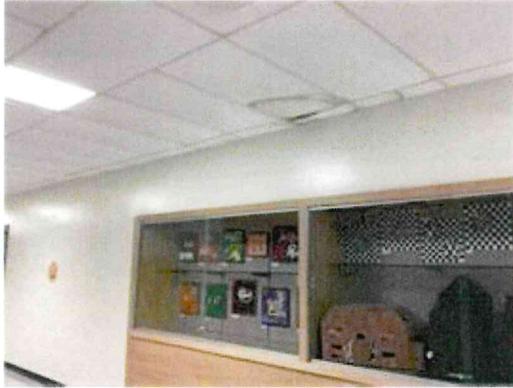
Title:	Roof Leak - Ceiling Tiles
Recommendation:	The roof leaks and the ceiling tile presents a possible mold exposure. The ceiling tiles should be replaced. Done

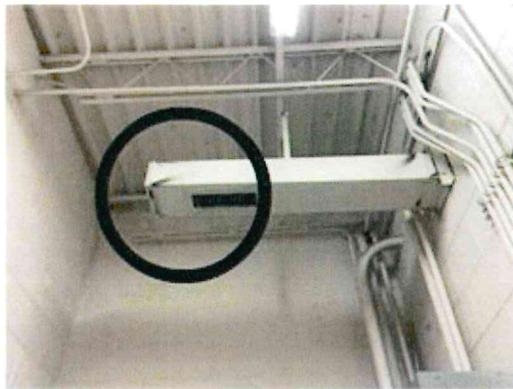
Title:	Vent Discoloration - Filter Change
Recommendation:	The discoloration around the vent indicated that the filters might not have been changed properly. The filters on the HVAC units should be changed and placed on the preventive maintenance schedule. Done - filter changed

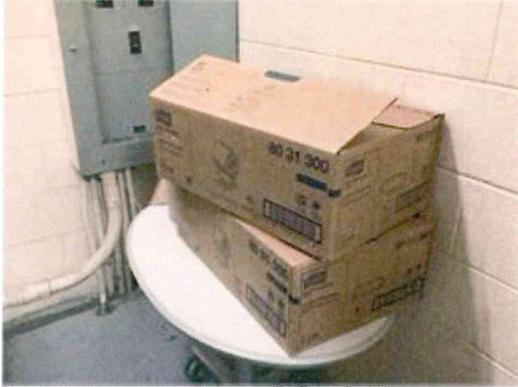
Title:	Electrical Panels Blocked
Recommendation:	Remove the items and materials being stored in front of the electrical panels per NFPA Life Safety Codes. There should be a minimum of 3-feet of clearance in front of and around the panels. Yellow caution lines could be painted to designate the area around the electrical panels where storage is not permitted.

Done

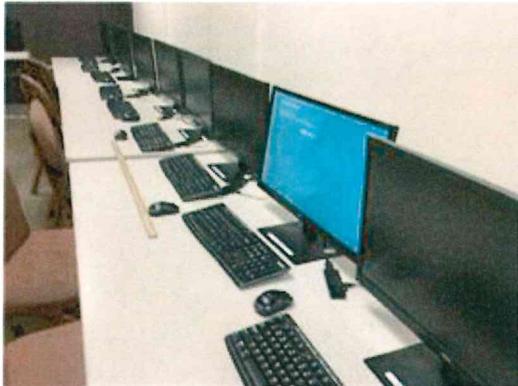
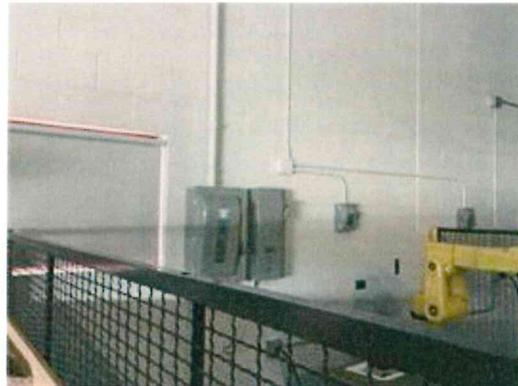
Title:	Turn Off Computers
Recommendation:	The computers in the media center are not being used. The computers should be turned off when not in use to prevent a potential for an electrical surge. In addition, the old robotics area has a number of large machines that the electrical should be turned off.

Done - note to staff

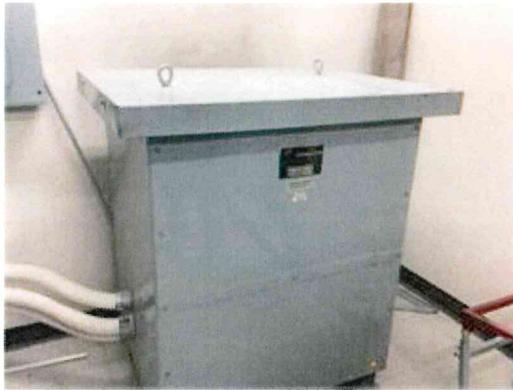
Title:	Electrical Inspection – Infra-red
Recommendation:	<p>Complete infrared testing of the district electrical systems every three years. The transformer in the electrical room was hot to the touch.</p> <p style="text-align: center;">Looking in to company that can perform this</p>

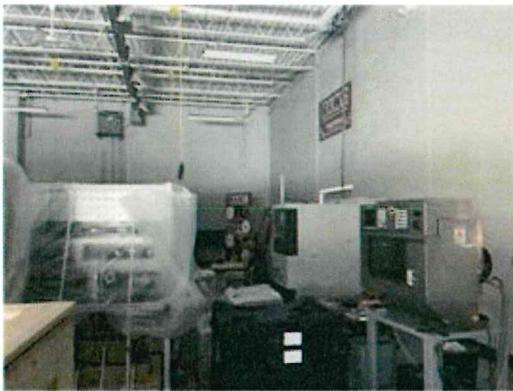
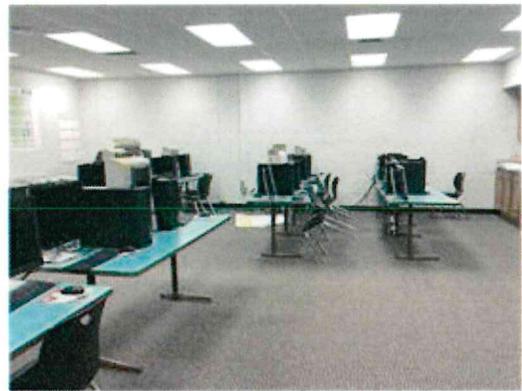
Title:	Robotic Program - Outside Vendor
Recommendation:	<p>The old robotics program that was run by the outside vendor still has all of the large expensive computer controlled equipment. Proper itemization of the equipment should be provided to SET SEG to ensure proper insurance coverage. Does equipment belong to the district or the third party vendor?</p> <p style="text-align: center;">Need to inventory</p>

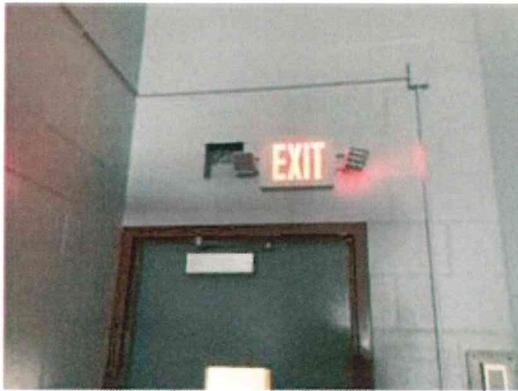
Title:	Electrical – Exposed Wiring
Recommendation:	<p>Electrical boxes should be closed by suitable covers and securely fastened in place. Various electrical control boxes, junction boxes and electrical receptacles were observed without covers or faceplates.</p> <p style="text-align: center;">In progress</p>

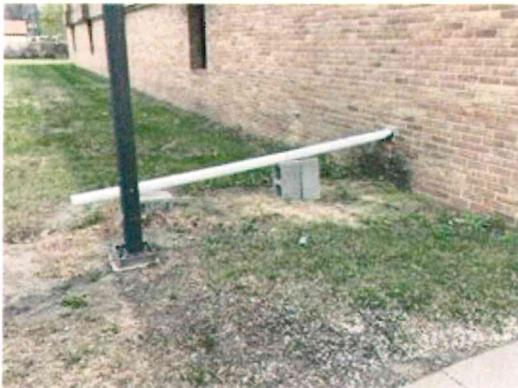
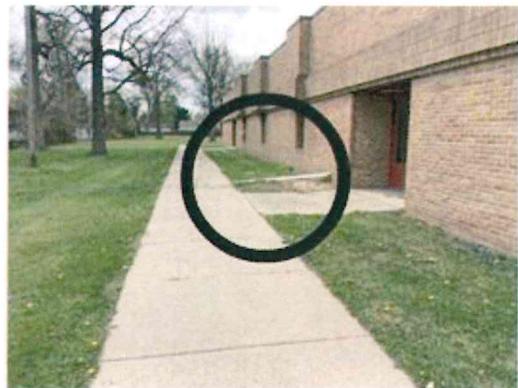
Title:	Pipe Extensions
Recommendation:	<p>There are several water pipe extensions around the middle school. While these extensions help the water to drain away from the building, the piping itself presents a trip and fall hazard, especially in the winter when the area is covered in snow. The pipe extensions should be buried.</p> <p style="text-align: center;">Will get quote from landscape contractors</p>

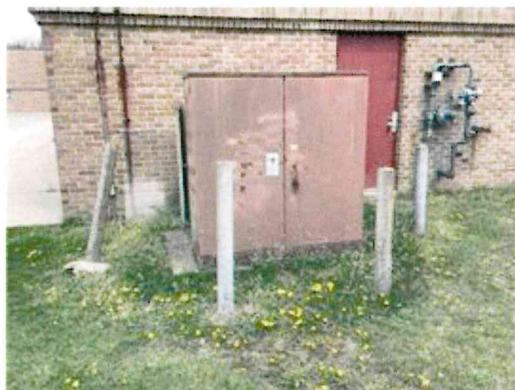
Title:	Outside Transformer
Recommendation:	<p>The outside transformer belongs to DTE. The poles protecting the transformer are damaged and should be repaired.</p> <p>Will contact DTE</p>

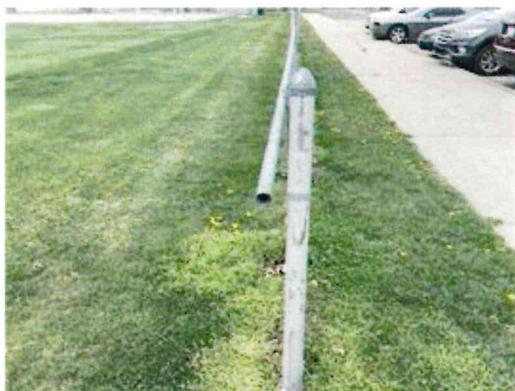
Title:	Repair Fence
Recommendation:	<p>The fence should be repaired.</p> <p>Scheduled to be fixed this week.</p>

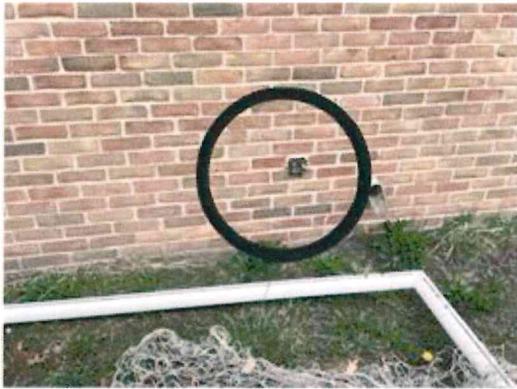
Title:	Light Pole is Tethered to a Tree
Recommendation:	The light pole is tethered to a tree on the east side of the building. The structural integrity of the light pole should be investigated. Pole was investigated, it is not tethered to a tree, it is a line coming from the DTE power poles.

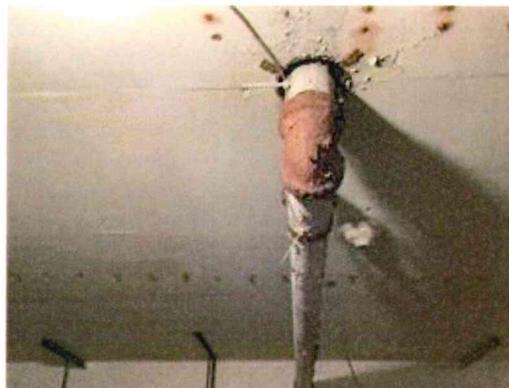
Title:	Pool Area - Motor and Piping
Recommendation:	The motor in the pool area is very noisy and needs to be repaired. The drain pipe from the pool in the tunnel area is corroded and should be replaced prior to it leaking.
	Motor has been replaced Will have pipe inspected

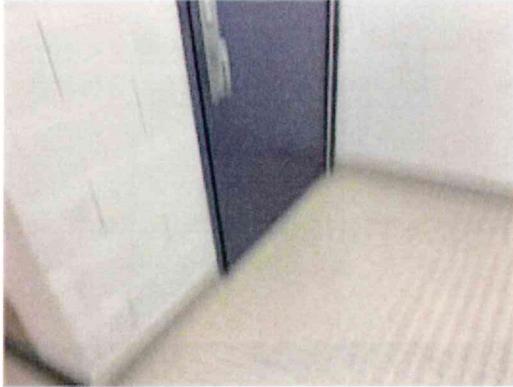
Title:	Breach in Security
Recommendation:	The locker room door is being propped open when there is no supervision. The locker room leads to the pool which if left unsupervised unauthorized individuals could gain access to. Keep all doors securely closed and locked to help minimize a breach in security and potential loss.
	Done

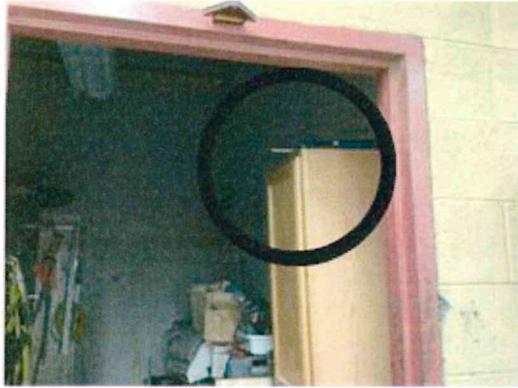
Title:	Flammable Liquid Storage
Recommendation:	Store all flammables such as paints, thinners, adhesives and aerosols inside a UL approved cabinet for storage of the flammables. These cabinets are specially designed to isolate the flammable liquids from a fire, reducing the potential for their contributing to the rapid spread of a fire. There were a couple of propane torches. These should be removed or placed in a flammable cabinet. Flammables have been removed, looking in to cabinets for storage.
